#4. Taylor Creek aerial photo

4a. Taylor Density Area

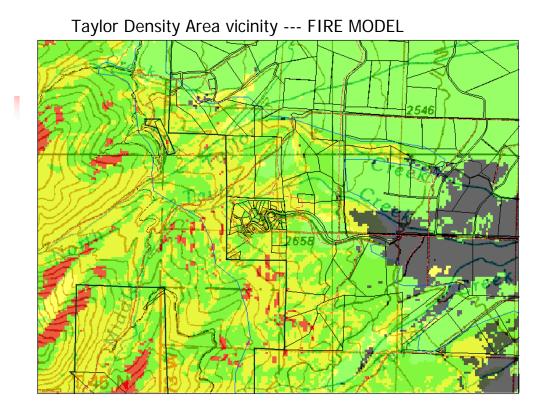
#4. Taylor Density Area is focused on the former ski area, and has a large lodge and conference center of high community value as well as small-lot residential areas. Dense forest obscures most homes in the photo, indicating extreme need for defensible space and fuel reduction.

Loop road system is very limited, and escape routes need development to the north (Hermit Road) and to the south (Taylor Highlands lots, Walker Ranch, Puls property and possibly out through Tanglewood subdivision.) Interspersed and adjacent meadows form good fuelbreaks and escape zones. Fire-fighting water sources are developed at the lodge and the recreational ponds on Muddy Lane.

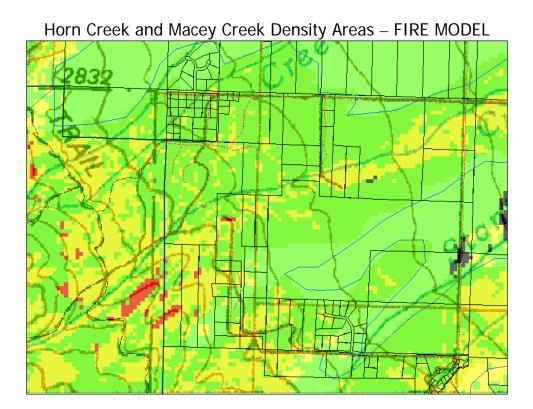
6a. Horn Creek Density Area

#6. Horn Creek and #7. Macey Creek Density Areas may be considered as one Landscape Neighborhood. Escape routes between the two need development for loops. Meadows are good firebreaks, but dense tree areas are extreme hazard. Water source is developed at Horn Creek camp (a very large community-value conference center and lodge), but other ponds need access and improvement. Main powerline is overhead and needs protection. National Forest buffer zone needed. A USFS fuel reduction project is under contract at Horn Creek Trailhead.

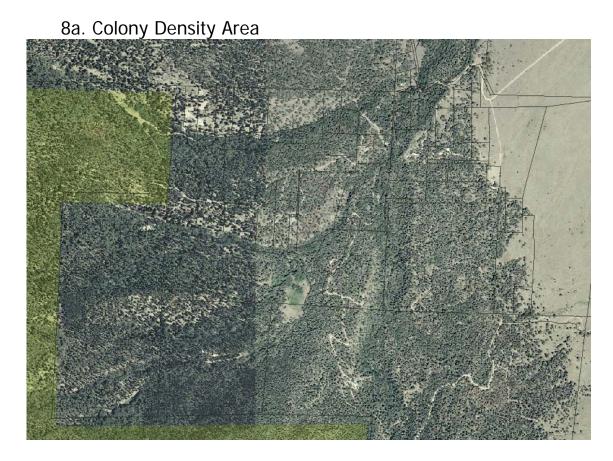
#8. Colony Density Area has steep roads, small lots, older cabins, dense forest, few meadows or firebreaks, no developed water sources. Cabins are hidden in the aerial photo, showing defensible space is needed. Hazard rating is very high. This is a very difficult area to protect from wildfire. Escape routes need development, identification, and agreements with owners to the north and south.

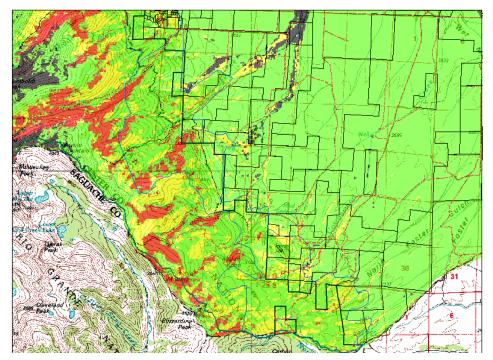
Music Pass area --- FIRE MODEL

#9. Music Pass does not have a high-density parcel area, is remote, has large meadows extending into National Forest. Red zones are not near many structures. Hazard Rating is low.

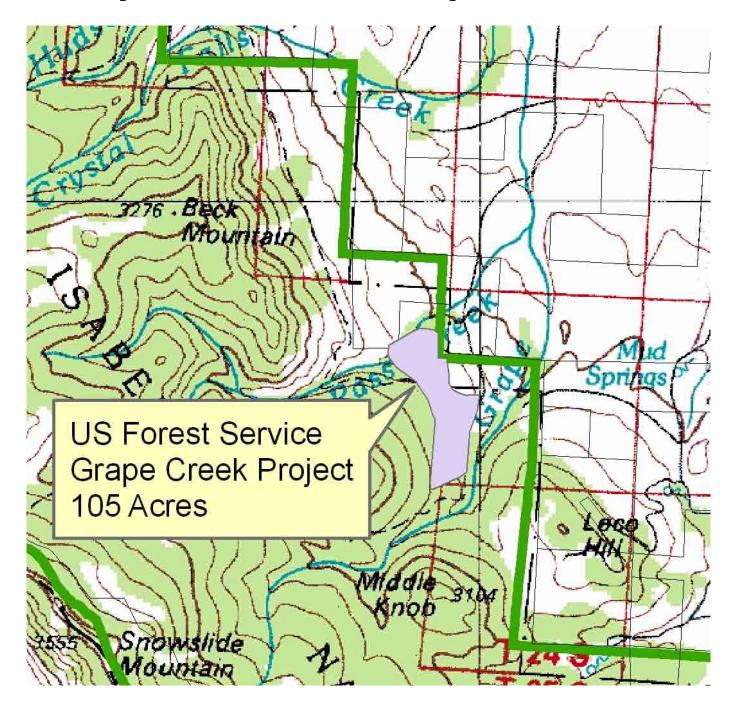
Music Pass USFS Project Area (Grape Creek)

a. In planning and scheduling stages. Dead tree concentrations due to mountain pine beetle and other insect/ disease problems.
