RE: Request for Proposals – Hermit/Grape Creek Crossing Project, County of Custer
Road & Bridge Department.

HERMIT/GRAPE CREEK CROSSING PROJECT
COUNTY OF CUSTER
REQUEST FOR PROPOSALS

Structure Inspection and Inventory Report (English Units)

Bridge Key: CUCO 0.50-6	Inspection Date: 01/12/2015	Sufficiency Rating: 65.1 SD
-------------------------	-----------------------------	-----------------------------

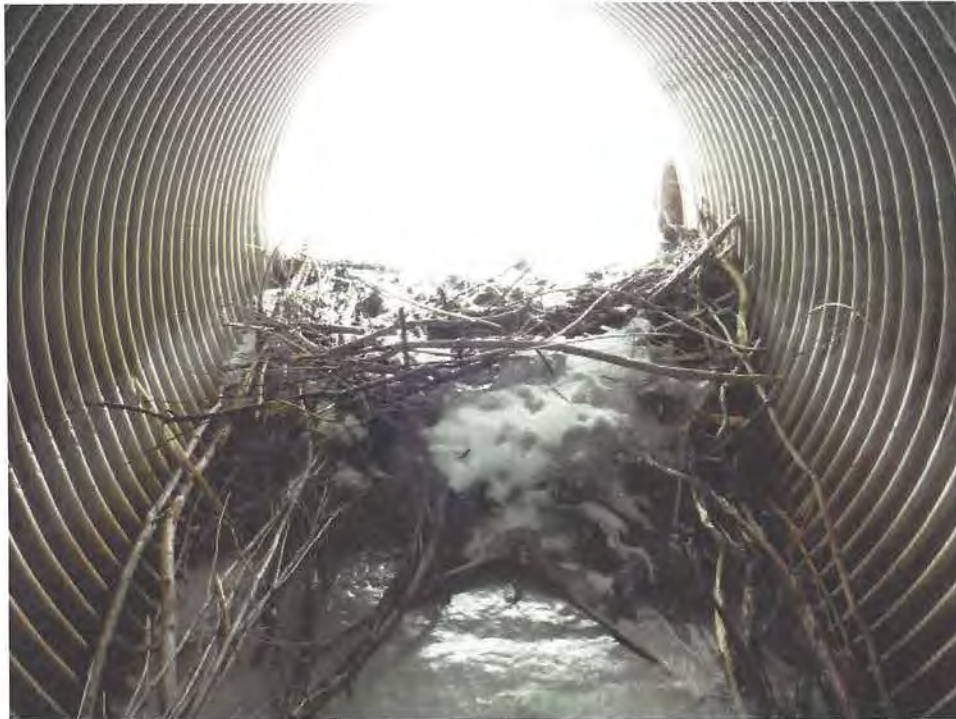
DEBRIS AND ICE AT INLET OF PIPE 1

515/1	Steel Protective Coating	
6000/1	Scour	Previous undermining filled with rock between 2009 - 2011 inspections. Pier 3 is undermined 16 inches on downstream end, see photo.
9327/1	Culvert Wingwalls	Concrete at south, stone masonry at northeast, new gabion baskets installed at northwest between 2009 - 2011. Bottom portion missing at northwest wingwall with 2 feet of undermining covered with ice in 2015. Horizontal crack at base of northeast wingwall. Honeycomb at south.
9335/1	Culvert Headwalls	Concrete at south, stone masonry at north. Honeycomb int south. Previous cracking and separation around barrels patched and filled with mortar between 2009 - 2011.
9501/1	Channel Cond	Gravel and sand turns slightly at bridge. Ponding due to debris blocking 50% of inlet in 2015.
9504/1	BankCond	Low, grassy. Erosion on west bank upstream and downstream.
9505/1	Debris Smart Flag	In 2015 all pipes were +/- 50% blocked with debris at inlets, see photos. Blockage is causing the channel to pond on upstream side.

Remove the debris from all pipes that is blocking the inlet.

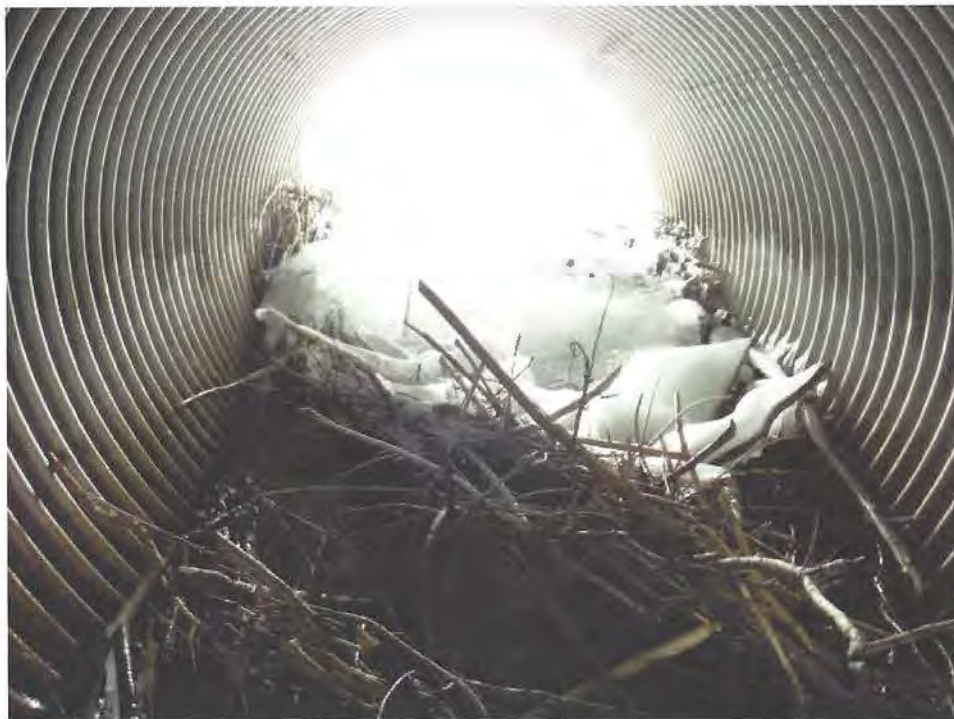
DEBRIS AND ICE AT INLET OF PIPE 2

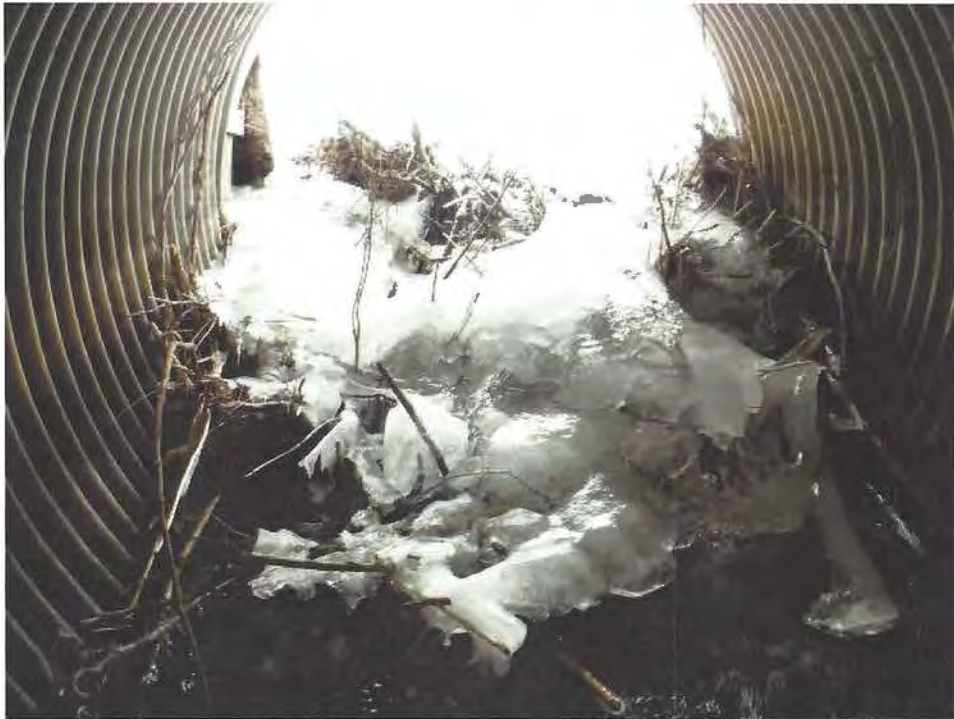
DEBRIS AND ICE AT INLET OF PIPE 3

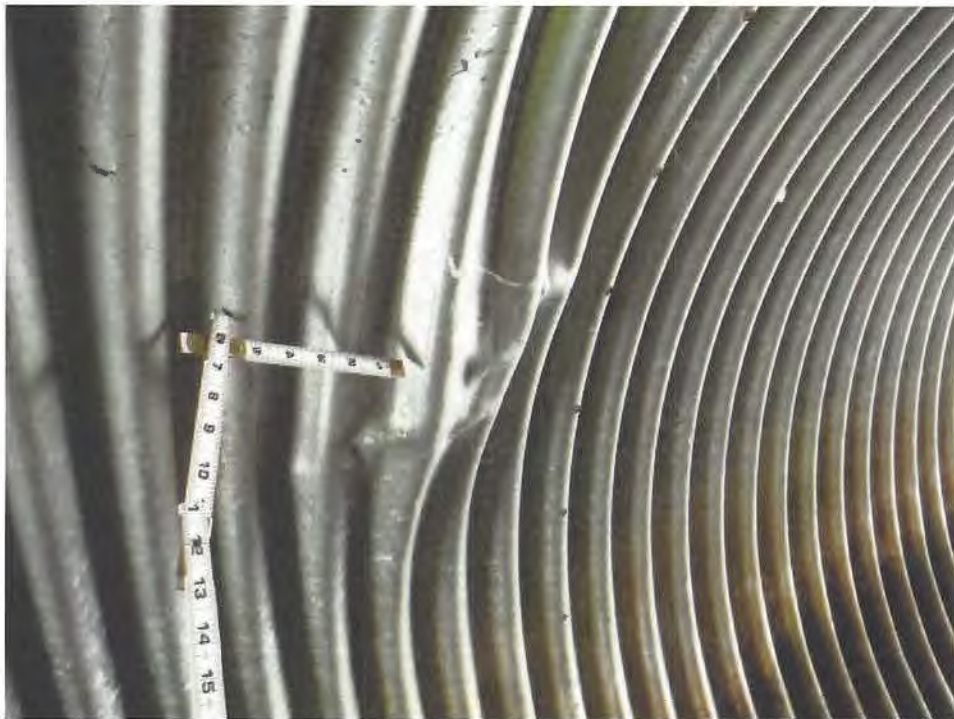
BULGE IN EAST SIDE OF PIPE 3 NEAR INLET

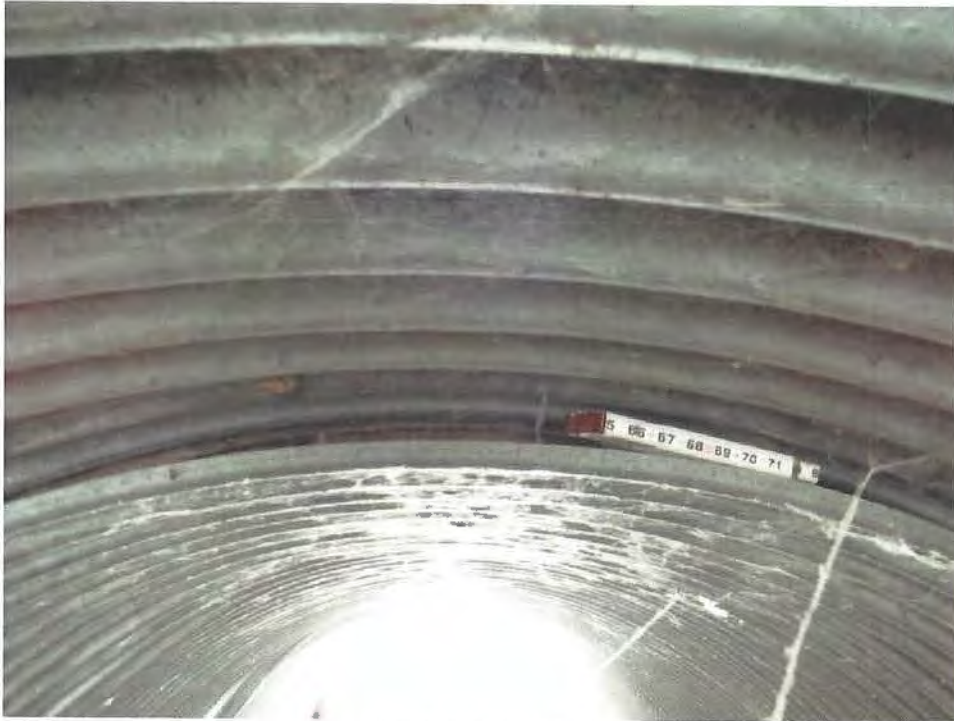
SEAM IN PIPE 3

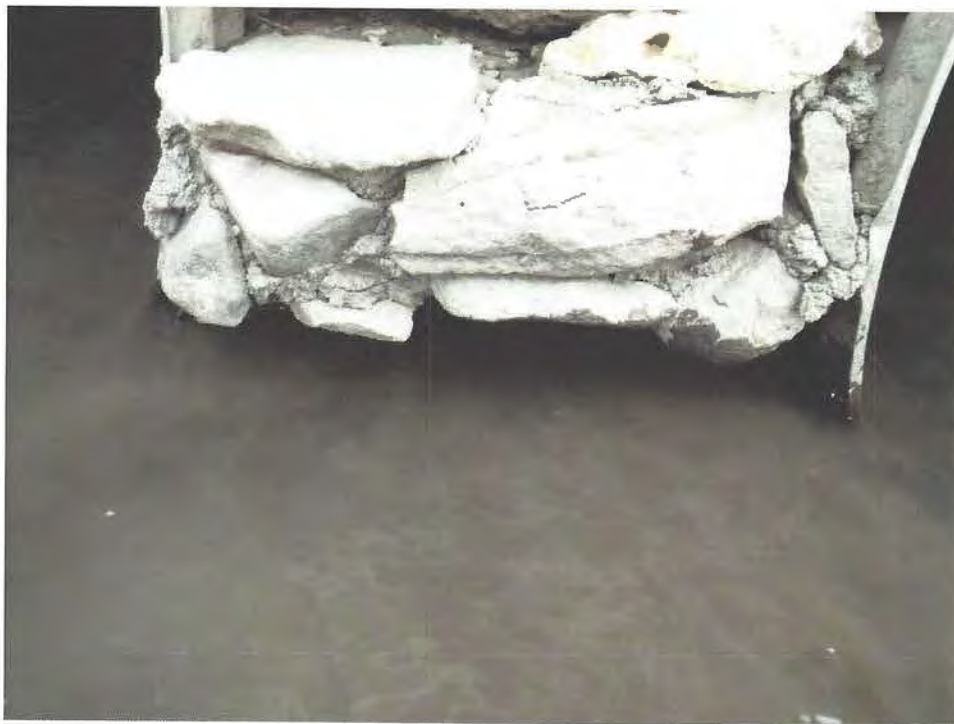
UNDERCUTTING OF PIER 3, DOWNSTREAM SIDE

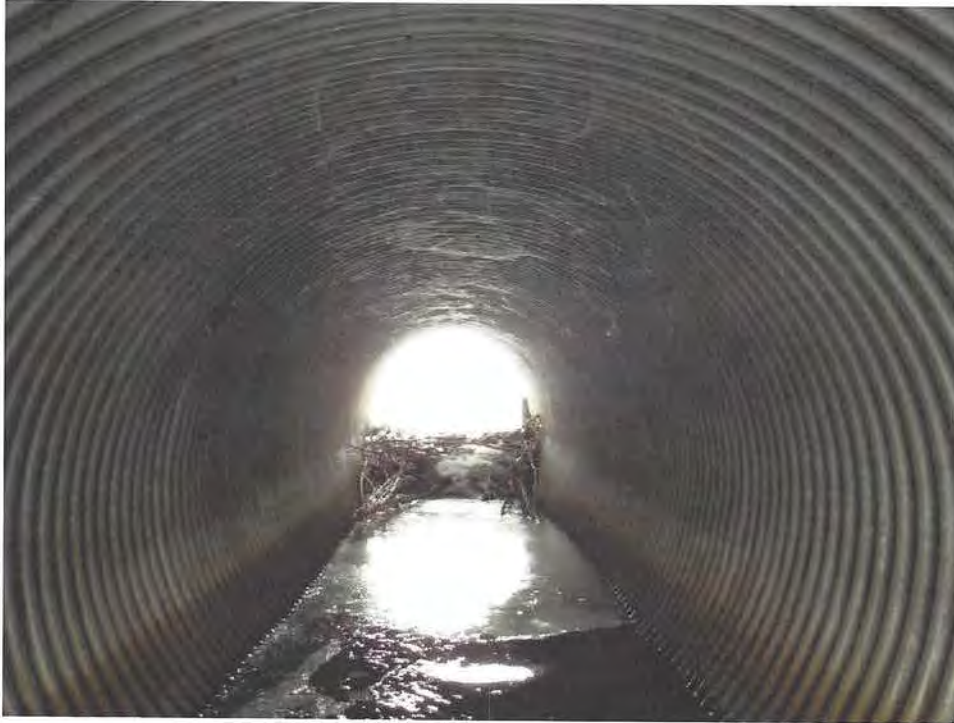
UNDERSIDE VIEW LOOKING SOUTH, PIPE 1

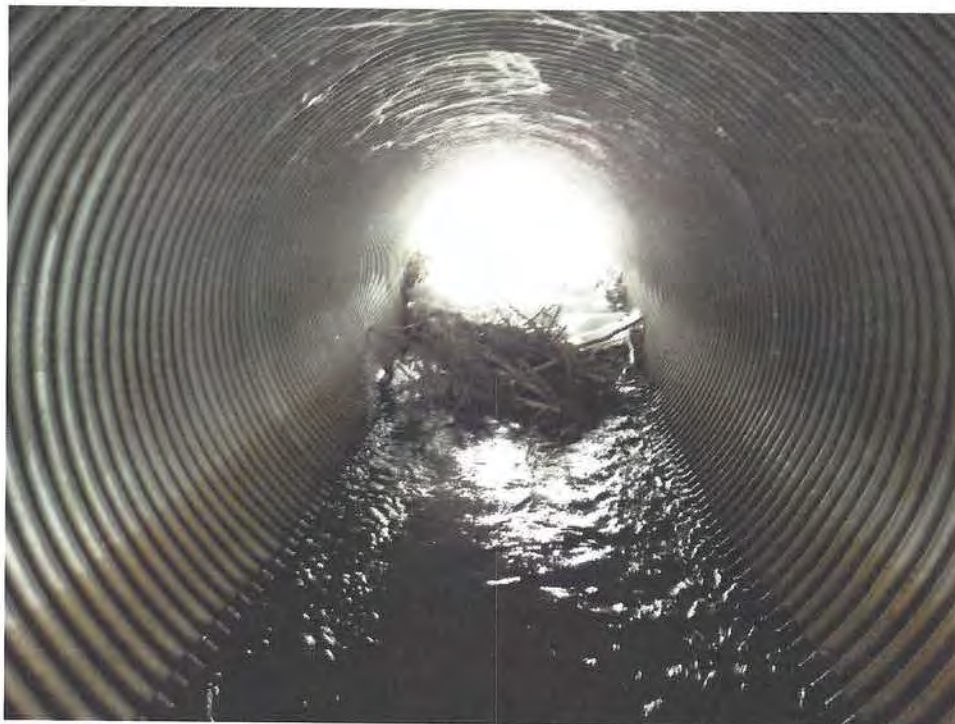
UNDERSIDE VIEW LOOKING SOUTH, PIPE 2

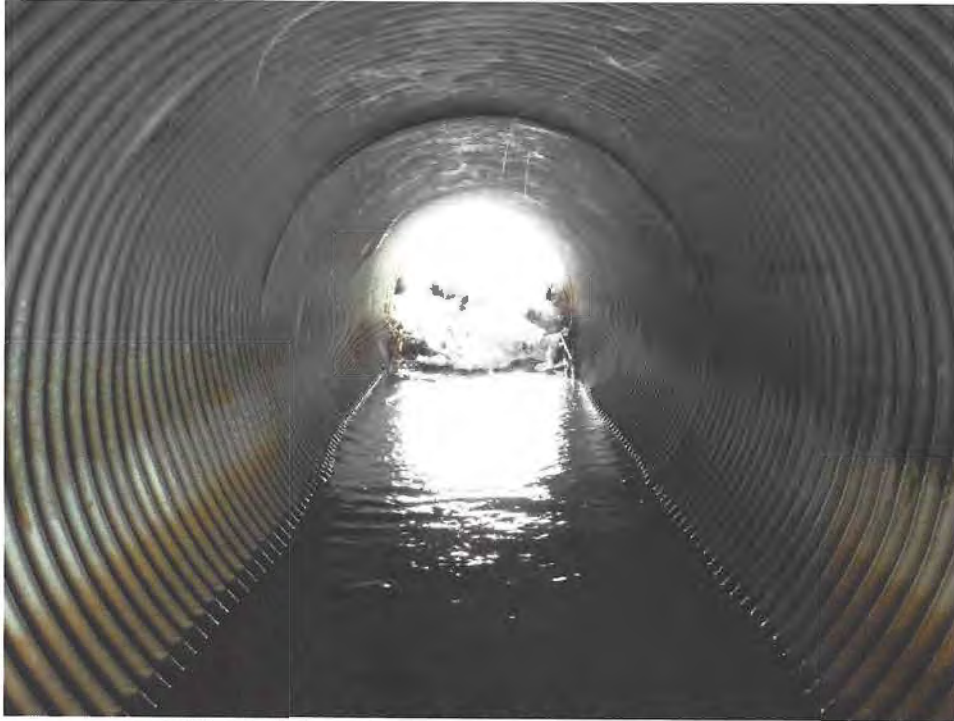
UNDERSIDE VIEW LOOKING SOUTH, PIPE 3
