#4. Taylor Creek aerial photo

4a. Taylor Density Area

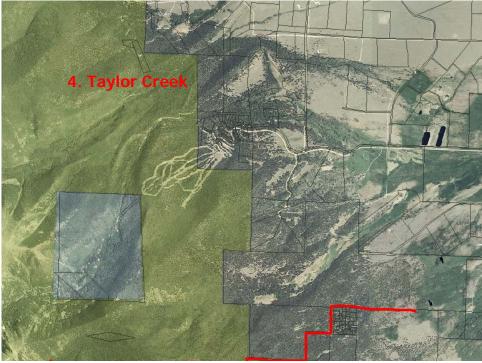
#4. Taylor Density Area is focused on the former ski area, and has a large lodge and conference center of high community value as well as small-lot residential areas. Dense forest obscures most homes in the photo, indicating extreme need for defensible space and fuel reduction.

Loop road system is very limited, and escape routes need development to the north (Hermit Road) and to the south (Taylor Highlands lots, Walker Ranch, Puls property and possibly out through Tanglewood subdivision.) Interspersed and adjacent meadows form good fuelbreaks and escape zones. Fire-fighting water sources are developed at the lodge and the recreational ponds on Muddy Lane.

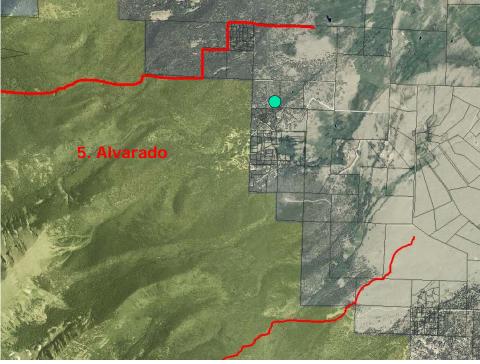
#5. Alvarado aerial photo

#5. Alvarado Density Areas include the Sangres and several older subdivisions. Perimeter forest needs reduction, and improved. National Forest boundary almost on the Rainbow Trail, limiting reduction project is under contract, largest Forest Service campground on the Interspersed and adjacent meadows are good. defensible space, access, and water sources buffer zones are needed. Wilderness Area is possible forest treatment areas. A USFS fuel starting as a timber sale.

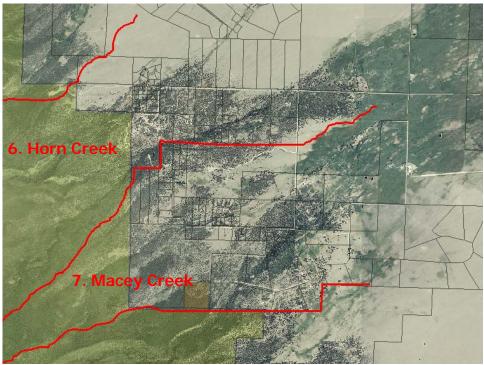
#6. Horn Creek and #7. Macey Creek aerial photo

#6. Horn Creek and #7. Macey Creek Density Areas may be considered as one Landscape Neighborhood. Escape routes between the two need development for loops. Meadows are good firebreaks, but dense tree areas are extreme hazard. Water source is developed at Horn Creek camp (a very large community-value conference center and lodge), but other ponds need access and improvement. Main powerline is overhead and needs protection. National Forest buffer zone needed. A USFS fuel reduction project is under contract at Horn Creek Trailhead.

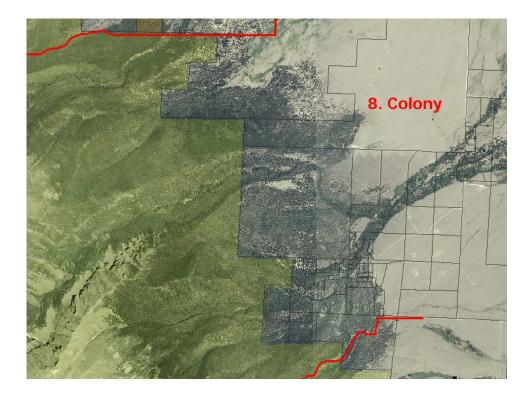
#8. Colony aerial photo

#8. Colony Density Area has steep roads, small lots, older cabins, dense forest, few meadows or firebreaks, no developed water sources. Cabins are hidden in the aerial photo, showing defensible space is needed. Hazard rating is very high. This is a very difficult area to protect from wildfire. Escape routes need development, identification, and agreements with owners to the north and south.

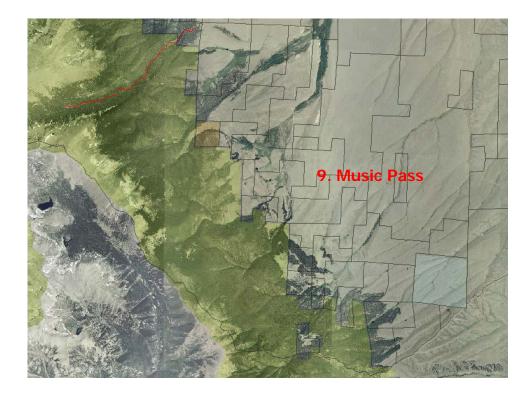
#9. Music Pass aerial photo

#9. Music Pass does not have a high-density parcel area, is remote, has large meadows extending into National Forest. Red zones are not near many structures. Hazard Rating is low.
